## IPP, Unit 2 LSB Erosion (270T151)

In April, MD&A inspected the last stage buckets of Intermountain #2 in the hoods to provide Intermountain Power with a second opinion concerning the need to replace the buckets during a planned outage in 2010. Intermountain #2 is a GE S2 turbine with 30" last stage buckets and steam conditions of 2400#/1000°F/1000°F that went into service in 1987. The turbine was originally rated at 820 MW but you reported that the HP sections of both Intermountain units have been replaced with Alstom upgrades so the output is now higher.

**RECOMMENDATIONS/CONCLUSIONS**

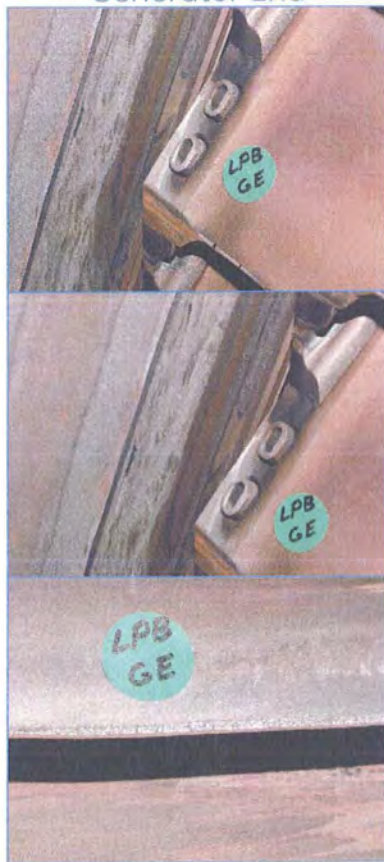
Generator End

## LPB Photographs

The L-0's on LP A, B, and C were visual and NDE examined per TIL-1521 and GEK46354. As noted in past IPP QC records there is erosion on Inlet Side of all L-0 Buckets.

Monitor LP L-0's per TIL-1521 and GEK46354 and replace on next major outage.
